# Electrocardiogram Interference: A Thing of the Past?

Luis A. Melendez and Richard M. Pino

### Abstract

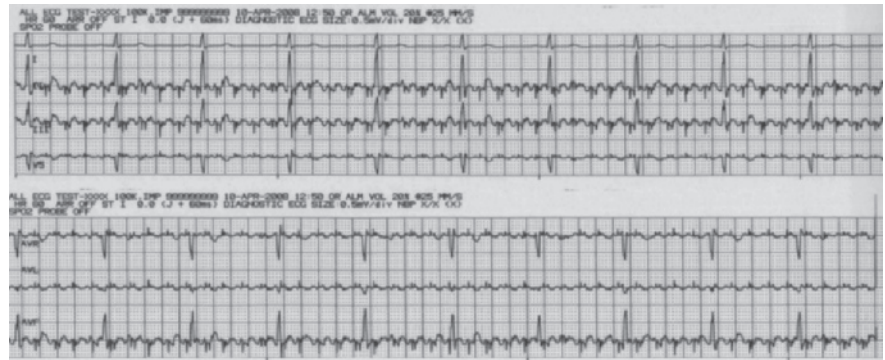
**Figure 2.** A) GE Solar 8000i monitor with <5k $\Omega$  on all electrodes and peristaltic pump running. B) GE 8000i monitor with 100k $\Omega$  on left leg, all other electrodes <5k $\Omega$ , and peristaltic pump running.

Both monitors undergoing laboratory testing behaved consistently (see Figures 2 and 3), and exhibited interference 100% of the time when impedance was set above 50k $\Omega$ . Indeterminate variability made precise interference reproducibility, even from controlled sources (e.g., peristaltic pumps), difficult.

All waveforms shown in Figure 2a and 3a, free of interference, were generated from monitors connected (as above) with the variable impedance decade box set to zero and the peristaltic pump running.

Waveforms in Figures 2b and 3b were generated under identical conditions, but with the left leg electrode at a higher impedance, and the decade box set to 100k $\Omega$ . The left and right arms had no additional impedance, so lead I in Figures 2b and 3b is free of interference. The left leg had an additional 100k $\Omega$  impedance; this electrode is used in all other ECG leads (except for the MCL displayed by the Philips monitor), all of which display interference.

Monitor ECG filters have user selectable settings that can change the characteristics of waveforms as well as amount and/or type of interference displayed. The strips generated from the monitor in Figure 2a and b have a frequency range of 0.05-100 Hz, while the monitor in Figure 3 a and b uses 0.05-150 Hz.

We established a baseline with all electrodes at the same low impedance and saw no visible interference (Figure 2a and 3a) with a pump running. With the left and right arm electrodes, and the right leg electrodes all at the same impedance, the interference detected at the right leg was the same as that detected in lead I (left arm to right arm). The monitor's differential amplifier common-mode rejection worked well for lead I, and the result was an interference-free lead I waveform (Figure 2b and 3b).

The voltage difference results with visible interference (noise) in leads II and III. The interference on leads II and III is not found on lead I (Figure 2b and 3b). With an impedance imbalance between the left and right leg electrodes, the monitor's differential amplifier common-mode rejection does not work well for leads II and III, and the result is a noisy waveform.

The impedance difference between the left and right leg electrodes (100k $\Omega$ ), depicted in figures 2b and 3b, produces a proportional voltage difference between the two electrodes. This difference negates the monitor's differential amplifier's ability to eliminate common mode interference on leads II and III. Since the monitor's filter design presumes all electrodes are at roughly the same impedance, Ohm's Law prevails and any lead that uses the left leg

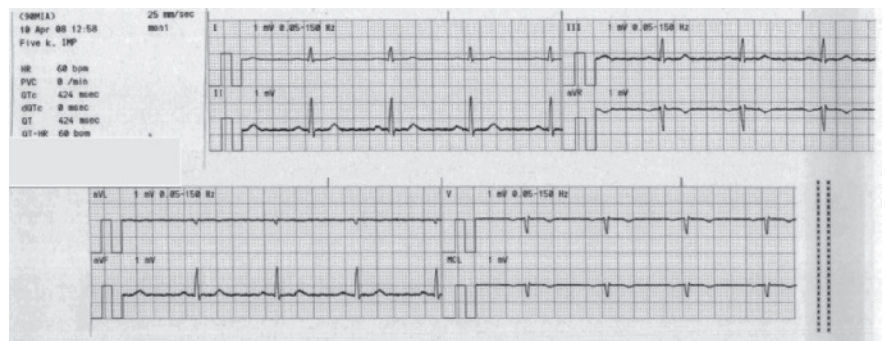
**Figure 3.** A) Philips MP70 monitor with <5k $\Omega$  on all electrodes and peristaltic pump running. B) Philips MP70 monitor with 100k $\Omega$  on left leg, all other electrodes <5k $\Omega$ , and peristaltic pump running.
